ENGINEERING INVESTIGATION REPORT

STEPHANIE AND MICHAEL WADSWORTH v. WALMART, INC. AND JETSON ELECTRIC BIKES, LLC

Case No.: 2:23-CV-00118
Location: 1620 Highway 374, Green River, Wyoming
Date of Loss: February 1, 2022
AEI Project No.: 15082

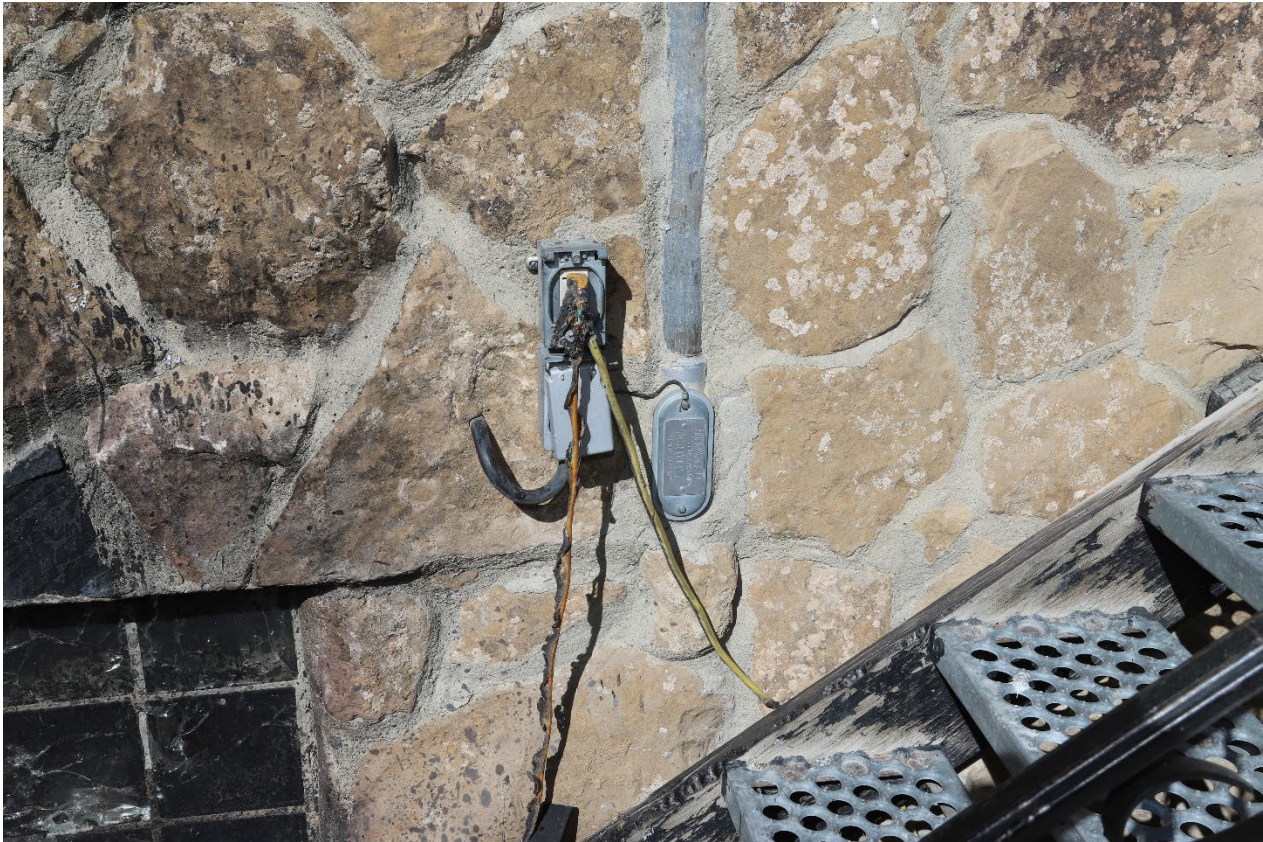
Figure 3. A NEMA 10-50R receptacle and a duplex NEMA 5-15R receptacle on the east exterior of the Residence. Two extension cords are plugged into the duplex receptacle (15082 BNS 1-032).

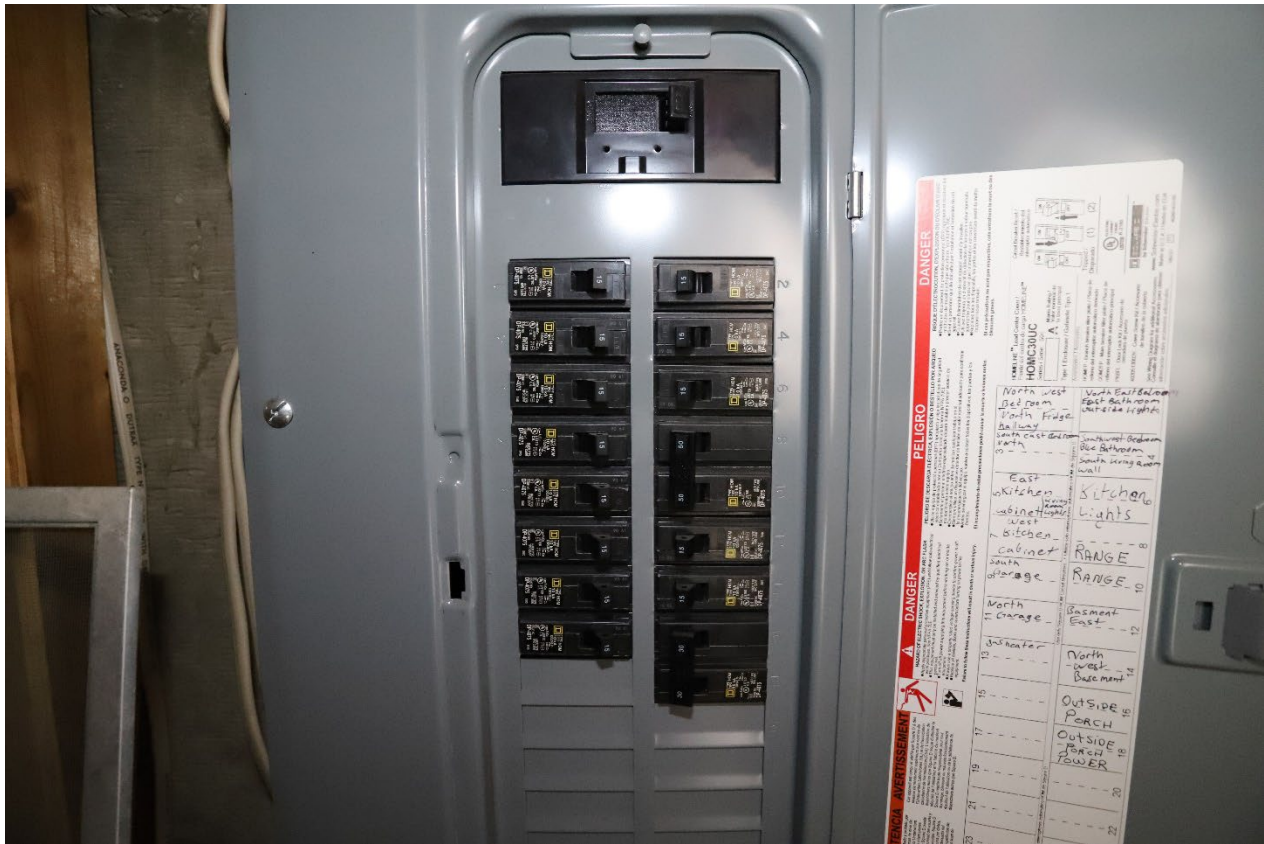
Both the main circuit breaker and all of the branch circuit breakers were standard thermal-magnetic circuit breakers without ground fault circuit interruption (GFCI) or arc fault circuit interruption (AFCI) capability. All of the circuit breakers in the main panel were in the 'ON' position (Figure 4). No circuit breakers were found in the tripped position; however, during removal from the main panel the circuit breaker in position 1 was accidentally dropped which caused it to trip.

Figure 4. Main electrical panel (15082 BNS 1-125).

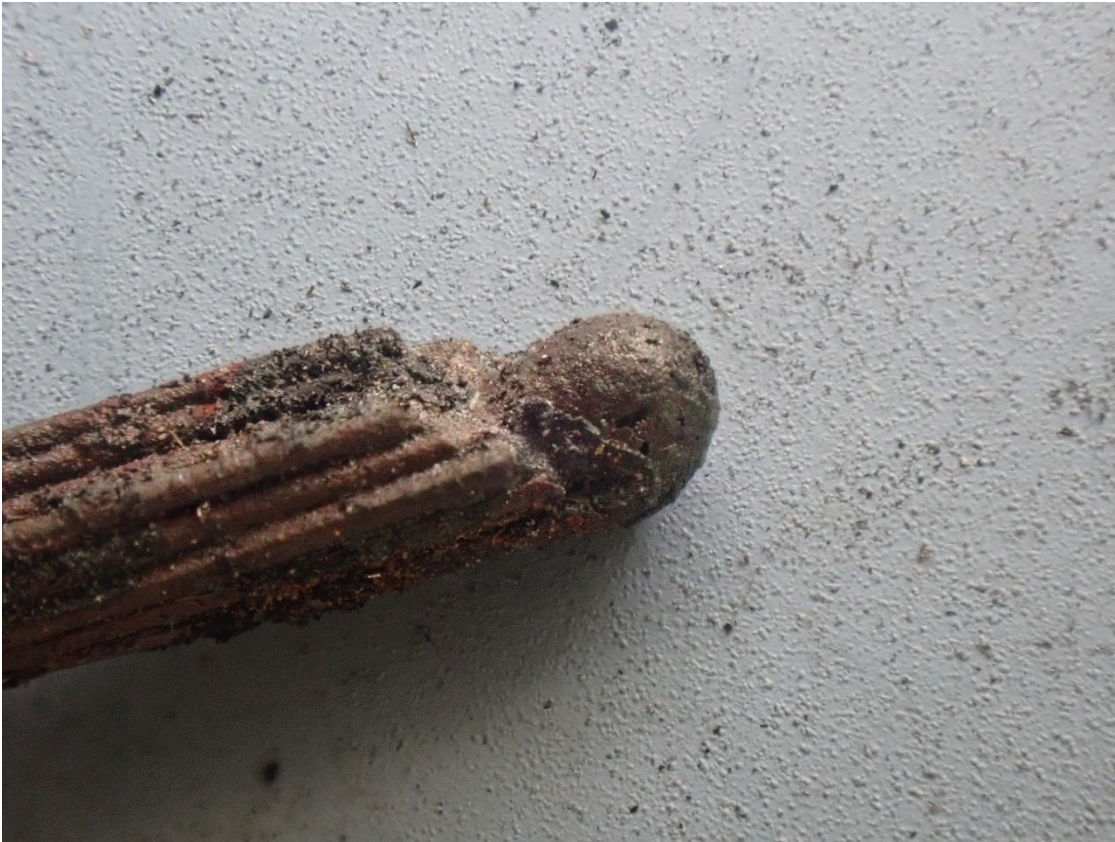
Two extension cords (one orange and one yellow in color) were plugged into the duplex receptacle on the east exterior of the Residence. The yellow extension cord ran to a metal post approximately 20 feet to the east of the Residence where it was connected to a splitter. Plugged into the splitter was a cord leading to an electrical box mounted on the post, a shore power cord for a camper trailer parked near the post and a second yellow extension cord which fed a bird bath de-icer in a polymer barrel of water located to the south of the remnants of the Smoking Shed on the east exterior of the Residence. The orange extension cord ran to the melted and resolidified mass of polymer in the location where the Smoking Shed once stood. Fragments of stranded copper conductors were present in and around the remnants of the Smoking Shed, some displaying visual evidence of electrical arcing (Figure 6). The remnants of the Smoking Shed and surrounding debris were preserved for further examination.

Figure 6. Evidence of electrical arcing on conductor found outside structure at Smoking Shed (15082 BNS 3-006).

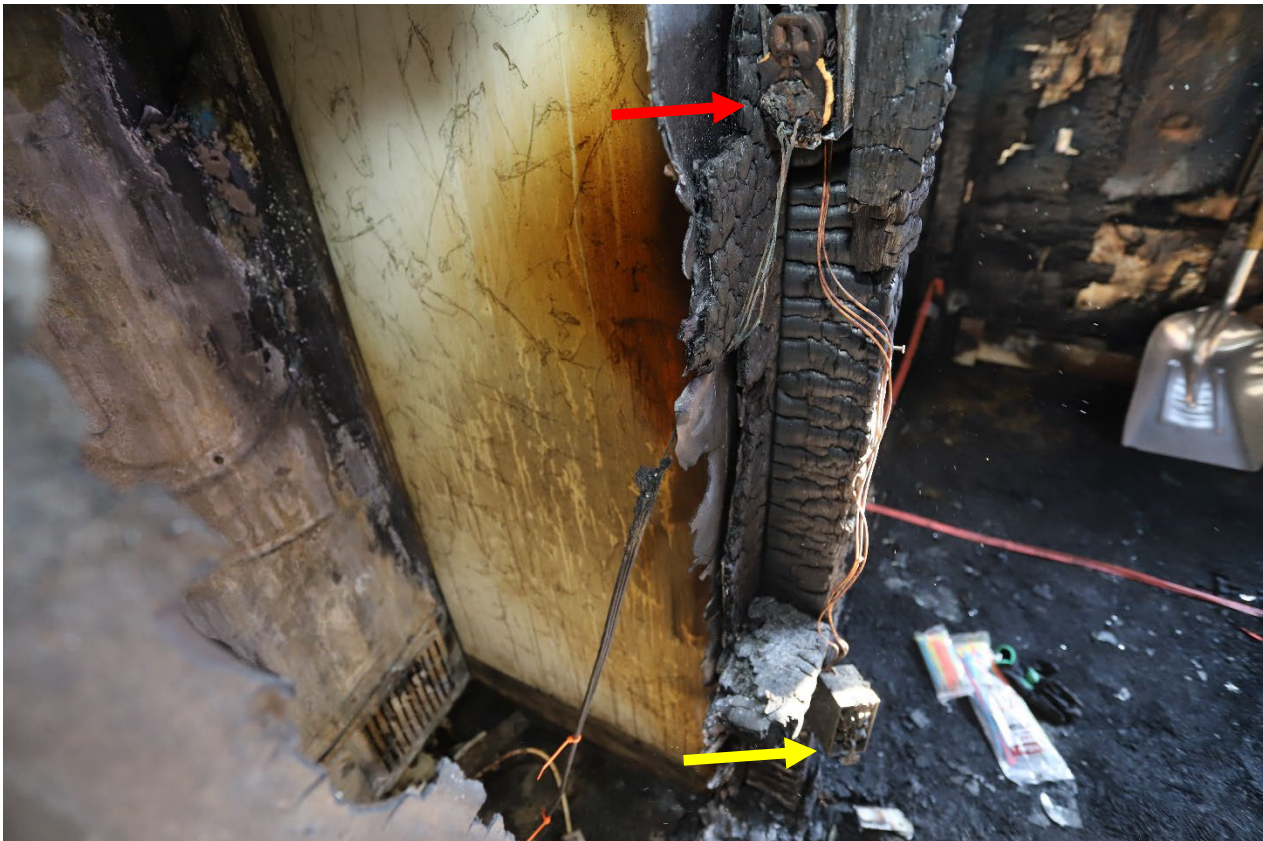
The blue painted NM cable ran up through the sill plate from the basement into Bedroom #4 near the location of the red painted NM cable. The blue painted NM cable ran to a ceiling mounted luminaire in the closet of Bedroom #4, then to a duplex receptacle in an adjacent room (kitchen, refrigerator receptacle), and then to R1. The insulation on this section of the branch circuit was entirely consumed by the fire. The power cord from the refrigerator in the kitchen was still plugged into its receptacle, there were no conductors plugged into receptacle R1 (Figure 8). The subject hoverboard was reportedly found on the floor in the area of receptacle R1.

Figure 8. Power cord for refrigerator plugged into receptacle (red arrow), and receptacle R1 with no cords plugged in (yellow arrow) (15082 BNS 4-035).

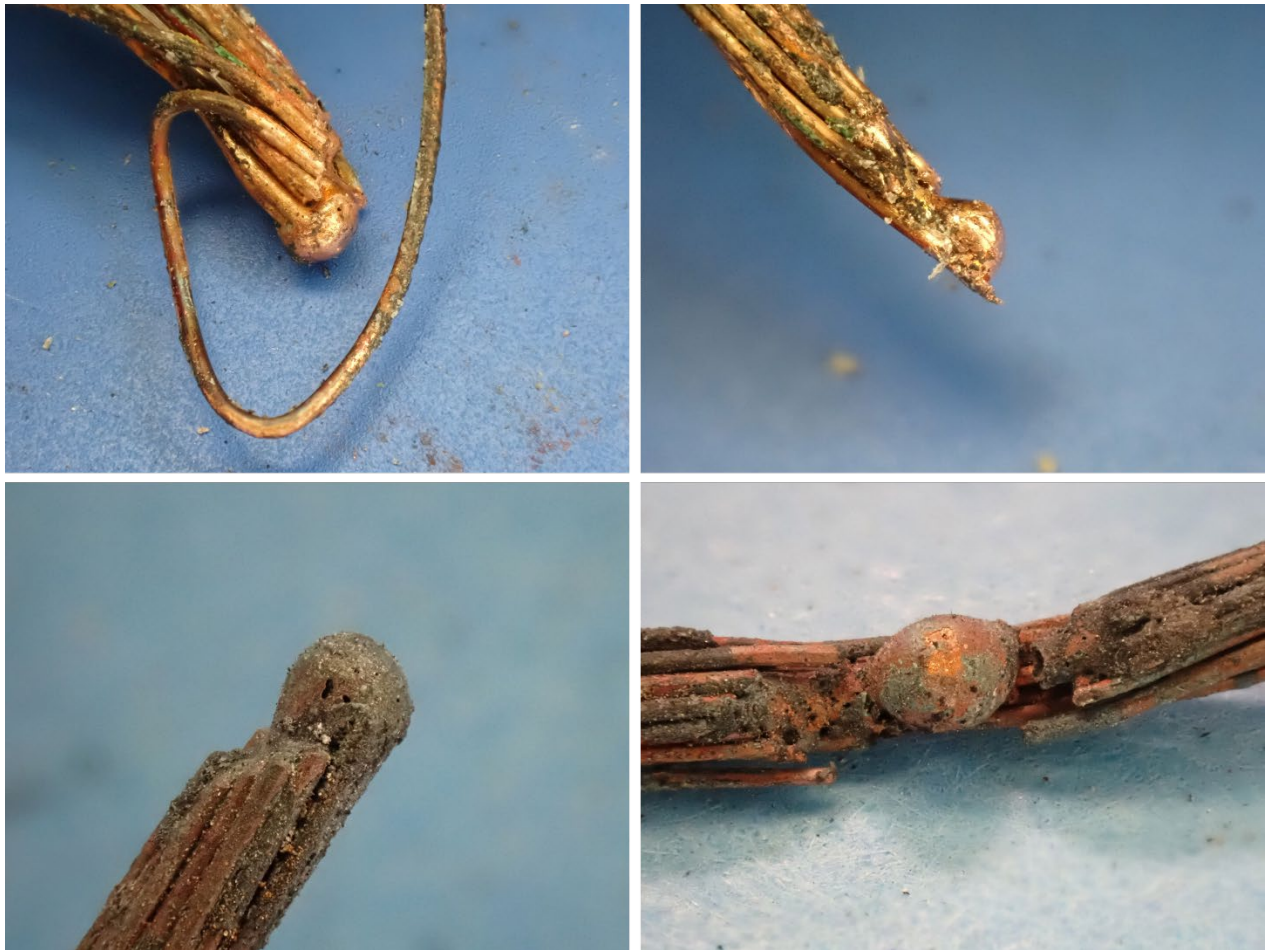
A laboratory examination of the artifacts preserved from the fire scene was conducted at the Palmer Engineering and Forensics facility in North Salt Lake City, Utah on October 30 and 31, 2023. Debris collected from the exterior of the Residence in the area of the Smoking Shed including the mass of melted and resolidified polymer that remained of the Smoking Shed was examined. Numerous stranded copper conductor fragments were found that contained evidence of electrical arcing (Figure 9).

Figure 9. Some of the instances of evidence of electrical arcing on conductors found in or around the Smoking Shed (15082 BNS 7-014, 7-106, 7-045, 7-066).

In the subject fire, stranded copper conductors present in the Smoking Shed, either extension cords or appliance (space heater) cords, or both, displayed evidence of electrical arcing proving that those cords were energized at the time that fire was present in the Smoking Shed. The entire branch circuit that supplied power to the receptacles and luminaires in Bedroom #4; however, contained no evidence of electrical arcing despite the electrical insulation being completely burned away on portions of the circuit. The insulation on the branch circuit wiring to the receptacle immediately adjacent to the location where the hoverboard was found was completely consumed in the fire; however, there was no evidence of electrical arcing on these conductors. The lack of any evidence of electrical arcing occurring in the fire damaged branch circuit conductors located in Bedroom #4 and the lack of any tripped circuit breakers in the electrical panel for the Residence (including the branch circuit breaker for Bedroom #4) was consistent with the branch circuit supplying power to Bedroom #4 being de-energized at the time that the fire attacked the branch circuit conductors in the bedroom.

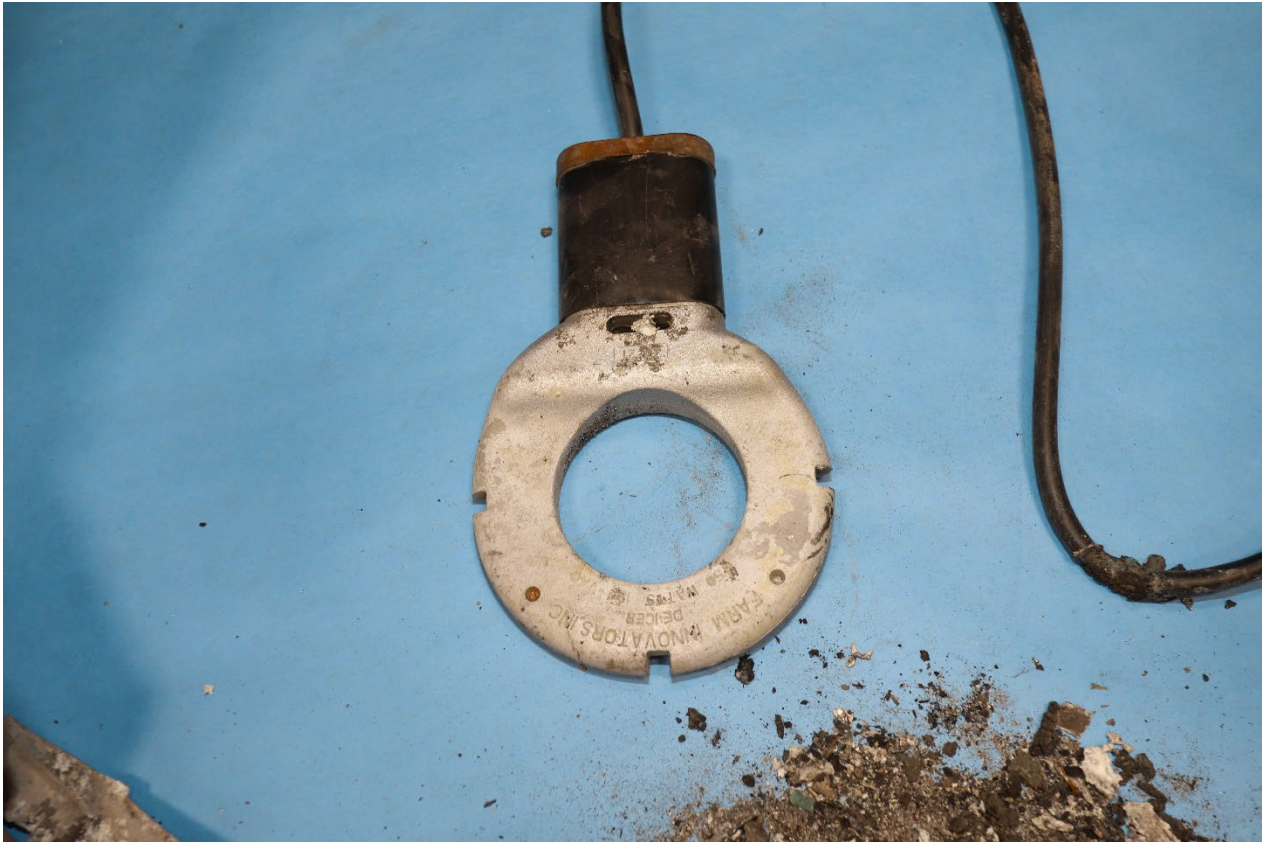
The power cord for bird bath de-icer and the yellow jacketed extension cord it was plugged into were both thermally damaged in the area where the cords were located near the Smoking Shed. The body of the bird bath de-icer was intact and not fire damaged (Figure 10). There was no evidence of a failure of the bird bath de-icer.

Figure 10. Bird bath de-icer not fire damaged (15082 BNS 5-054).

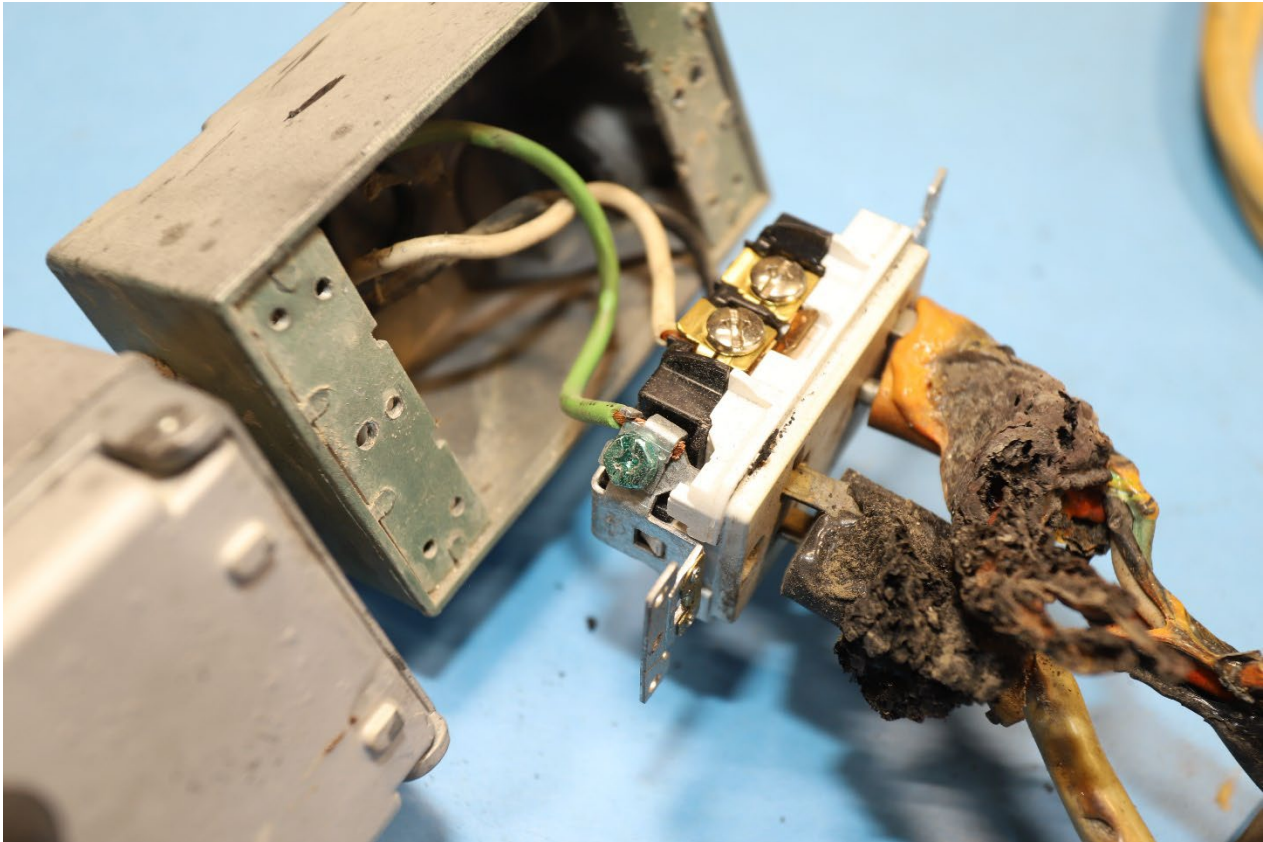
The 50-ampere and duplex 20-ampere receptacle from the east exterior of the Residence were opened for examination. The 50-ampere receptacle was fed by an 8-gauge, 3 conductor (8/3), type SO cord from a two-pole, 30-ampere, branch circuit breaker in the main panel. The duplex 20-ampere receptacle was fed by smaller gauge conductors tapped into the screw terminals on the 50-ampere receptacle. The grounding tab on the duplex receptacle was wired to the metal switch box that housed the receptacle and an uninsulated stranded conductor exited the switch box through a drilled hole. The other end of the uninsulated conductor had been bolted to a metal conduit connected to the meter base at the Residence. Neither of the receptacles were fire damaged. Two extension cords, a (second) yellow jacketed cord, and an orange jacketed cord were plugged into the duplex receptacle (Figure 11). The extension cord jackets and the plug ends were thermally damaged from the outside. There was no evidence of a failure at the receptacles.

Figure 11. Two extension cords plugged into the duplex receptacle on the east exterior of the Residence (15082 BNS 5-099).

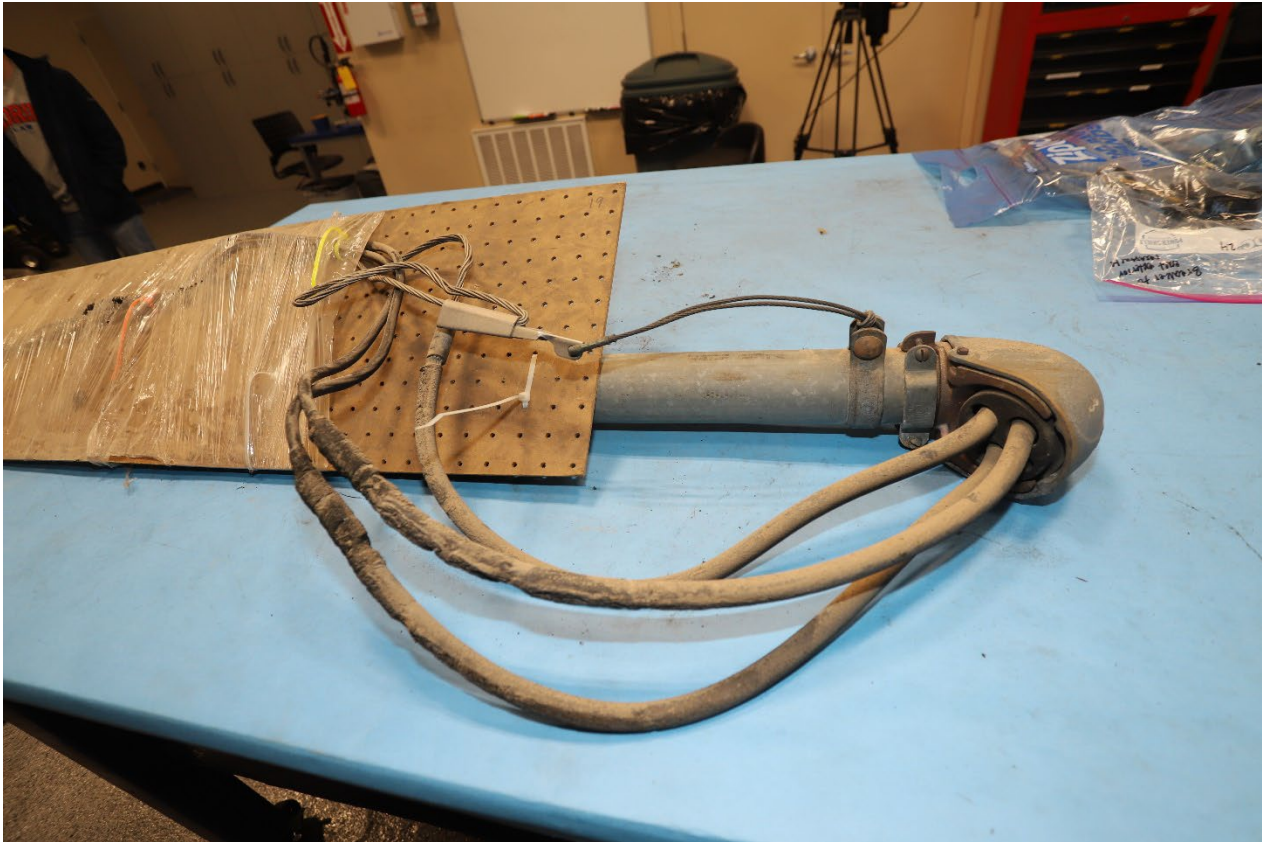
The weatherhead and remnants of the service triplex were examined (Figure 12). The weatherhead was not fire damaged. Thermal damage was present on the insulation on the individual service entrance conductors near the connections to the service triplex conductors. The service triplex conductors were melted and severed several feet from the connection point to the service entrance conductors to the Residence in the area that would have been overhead of the location of the Smoking Shed.

Figure 12. Weatherhead not fire damaged (15082 BNS 5-266).

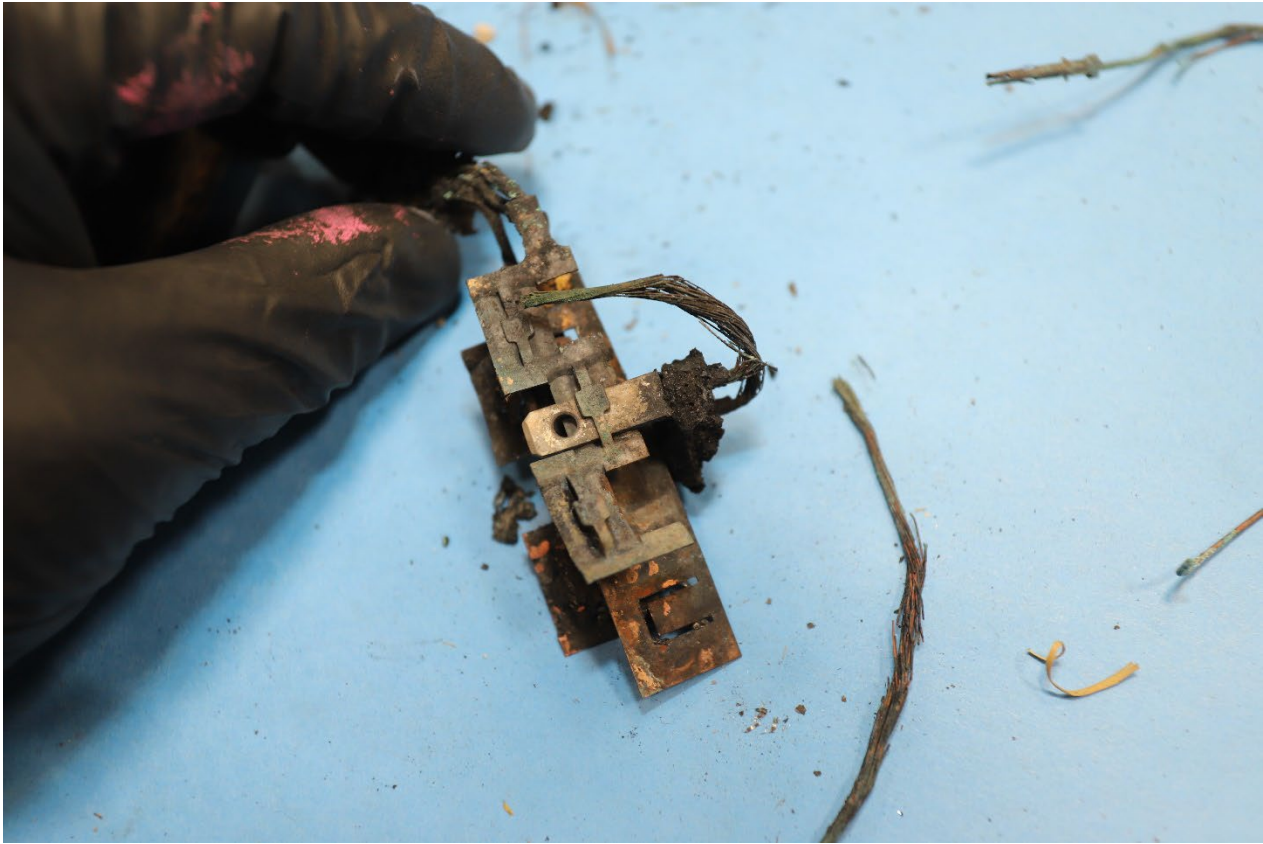
A three-position power tap from the end of an extension cord with two plug blades present in one of the positions recovered from the area of the Smoking Shed was examined (Figure 13). There was no evidence of electrical arcing at the plug connections nor any other evidence of a failure of the connections. The stranded copper conductors of the power tap were mechanically fractured several inches from the receptacle.

Figure 13. Three position power tap from the end of an extension cord with two plug blades from an unknown device still attached (15082 BNS 5-129).

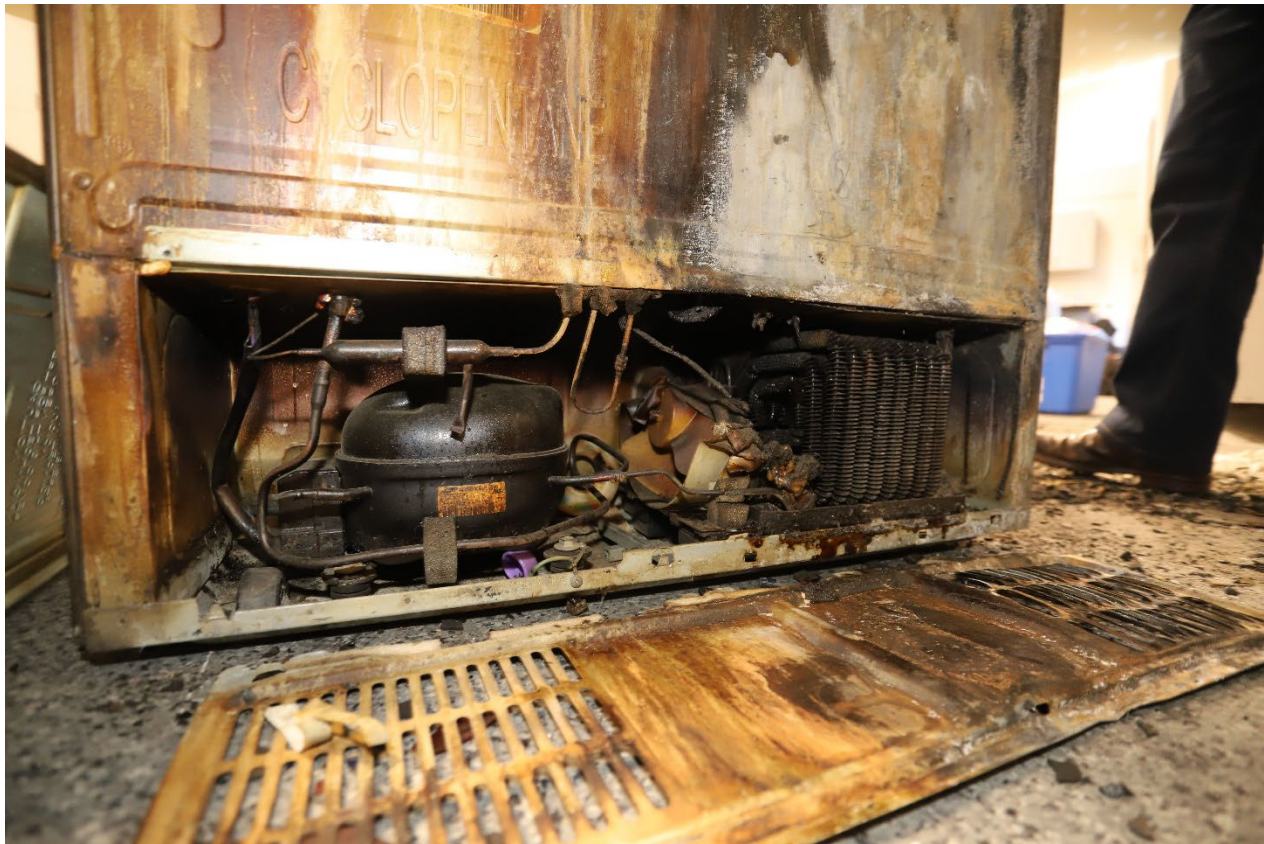
The refrigerator from the Residence was examined. The refrigerator was installed along the south wall of the kitchen on the opposite side of the Bedroom #4 wall where a hoverboard was reportedly found. The damage to the refrigerator was consistent with attack by an external fire. There was no evidence of a fire originating in the refrigerator (Figure 15)

Figure 15. Refrigerator compressor and condensing coil (15082 BNS 6-088).

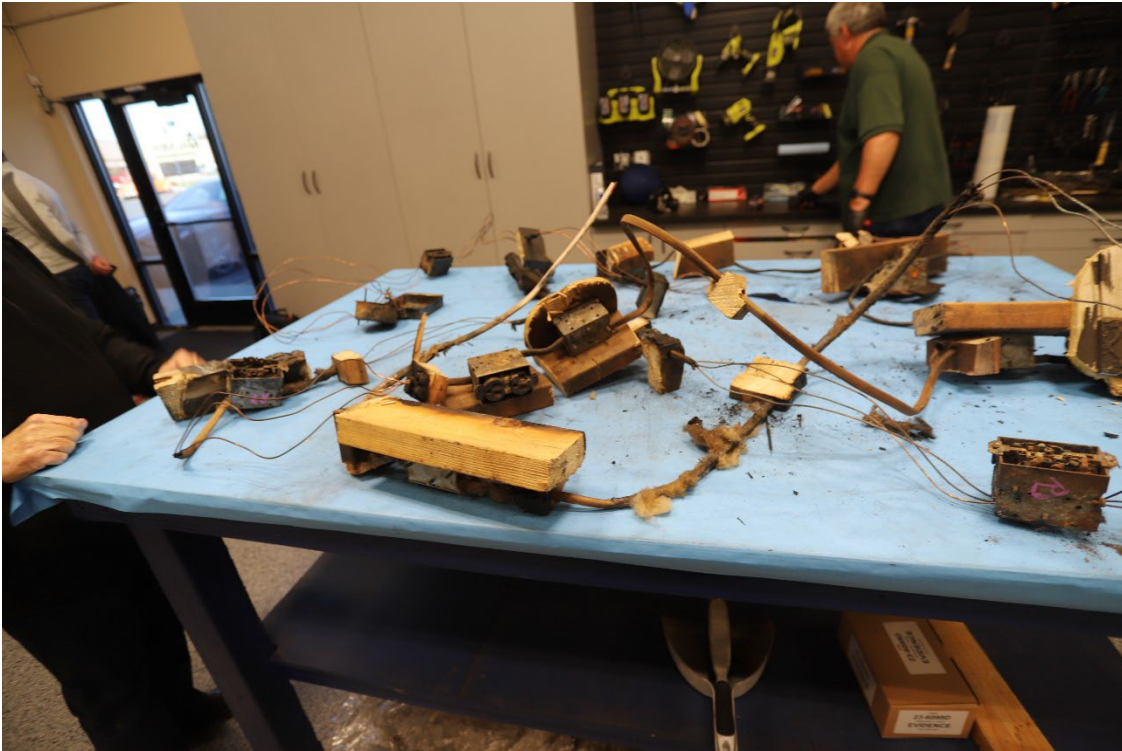
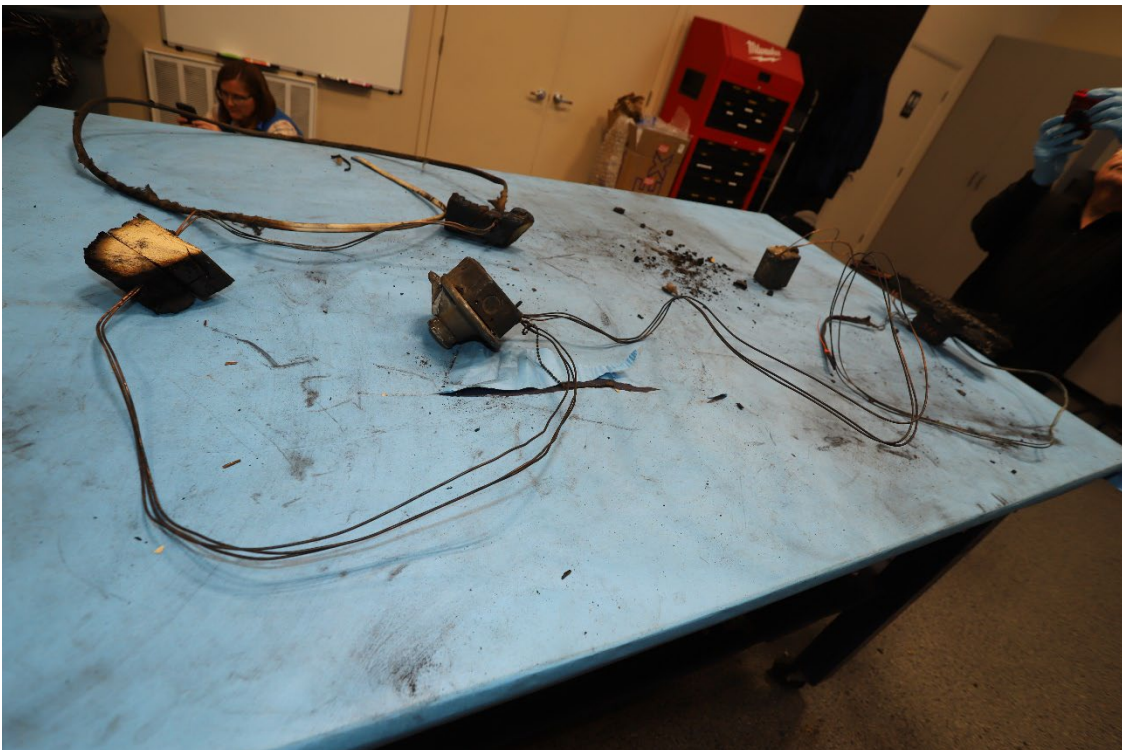
The entire branch circuit from within Bedroom #4 was examined (Figures 16 and 17). Despite much of the electrical insulation on the branch circuit conductors having been consumed by the fire, there was no evidence of electrical arcing on any of the conductors installed in Bedroom #4.

Figure 16. Branch circuit from southern portion of Bedroom #4 (15082 BNS 6-133).

Figure 17. Branch circuit from northern portion of Bedroom #4 (15082 BNS 6-215).
